Compact accident research

Safe intersections for vulnerable road users

German Insurance Association
German Insurers Accident Research

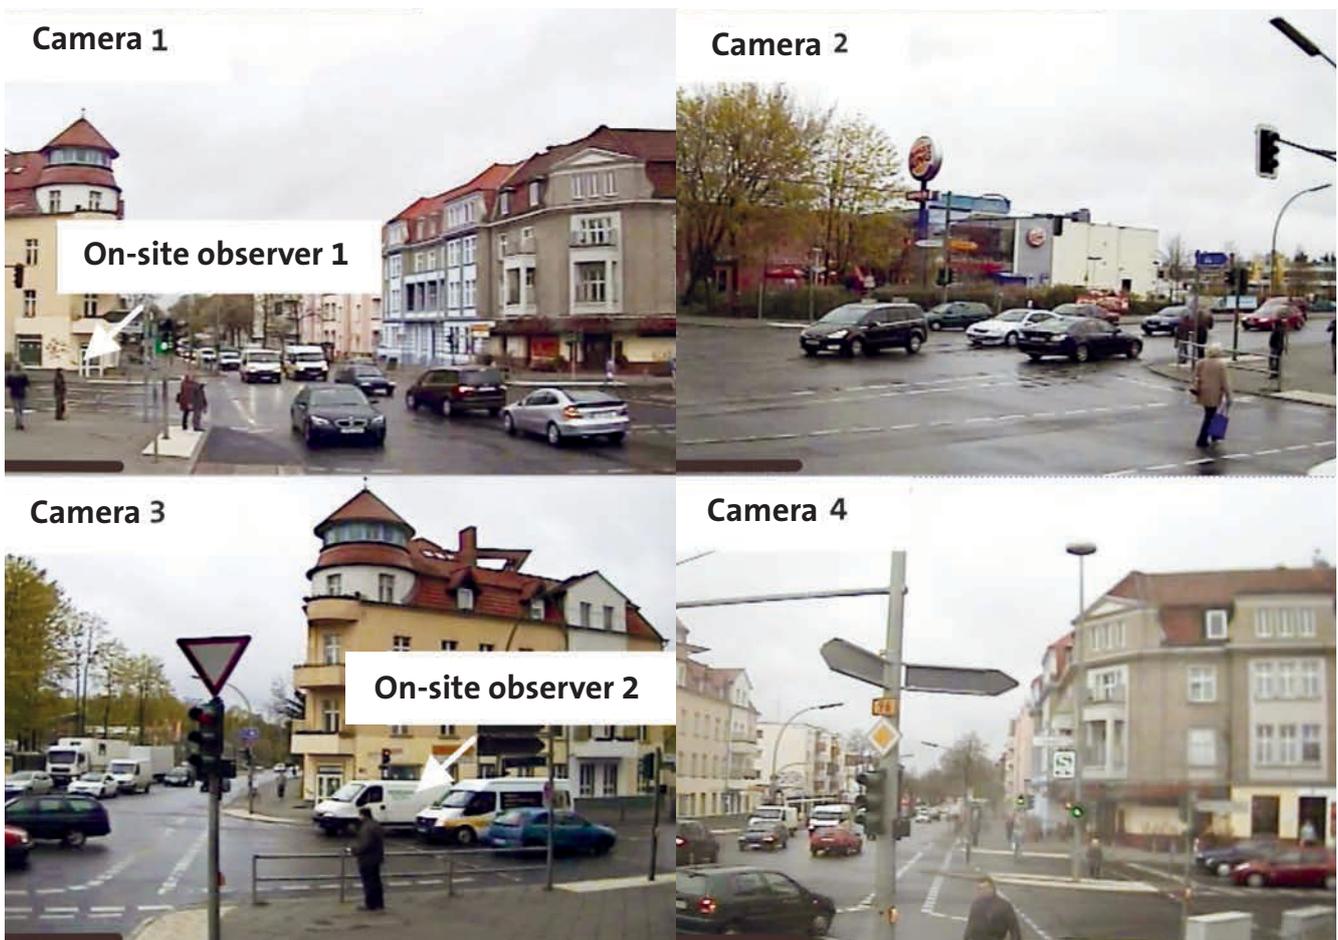
Figure 6: Example of camera images taken from four different angles of view

This approach made it possible to record the intersections from four different viewing angles (Figure 6).

The camera system consisted of four cameras (with transmitters), each of which was fixed to a stand, and a central receiver stand on which the receivers for all four cameras were mounted. The central receiver unit consisted of a hard disk recorder that was able to record the signals from all four cameras simultaneously.

The images recorded from the four cameras could then be perfectly synchronized and viewed simultaneously on a monitor during the subsequent assessment. If necessary, the images from a single camera were expanded to full-screen size for assessment purposes.

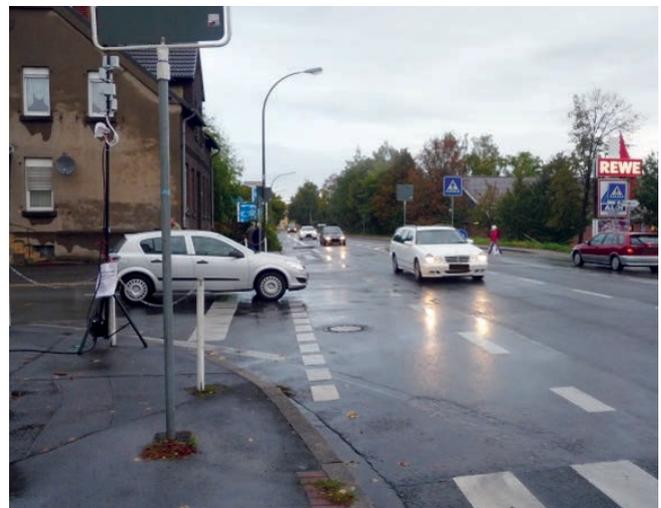
Figure 10: Restricted fields of visibility on approach

- (1) Restricted sight contacts and restricted fields of visibility on approach (Figure 10, Figure 11)
- (2) Absence of cycling facilities or cycling facilities not implemented in accordance with guidelines or regulations
- (3) Absence of facilities for people with particular mobility restrictions (e.g. rollators, baby buggies) or mobility-related disabilities (e.g. people with severe visual impair-

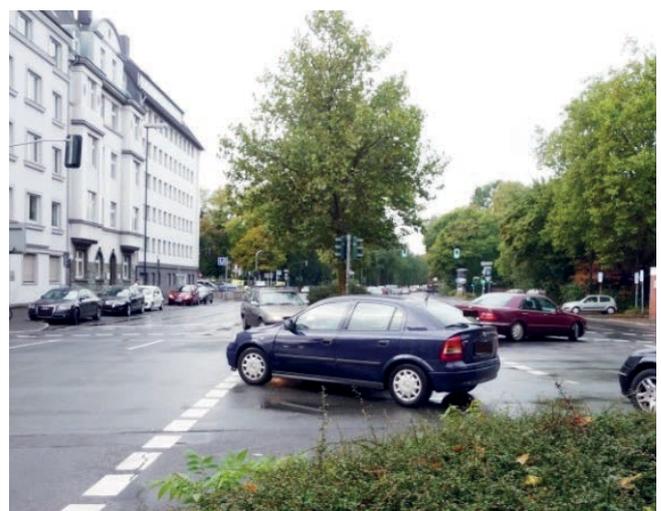
Figure 11: Impaired view for traffic turning left due to planted center strip and vehicles traveling in the opposite direction

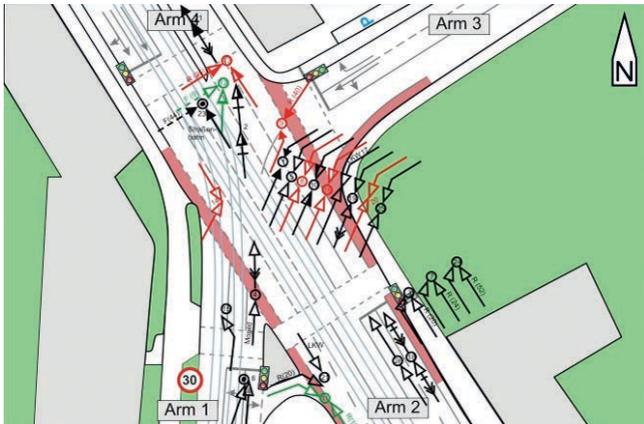
Figure 12: Accident chart at an intersection with no signal control for traffic routed left

- (1) Traffic routed left but not signal-controlled (Figure 12, Figure 13)
- (2) Absent or no longer recognizable traffic guidance (guidance lines, wait lines) for traffic turning left at junctions (Figure 13)
- (3) Traffic merging into one lane or moving out due to the routing of traffic turning left and through-traffic on a single lane (when there is more than one lane on the approach road) or due to the removal of a lane after the junction (Figure 14).

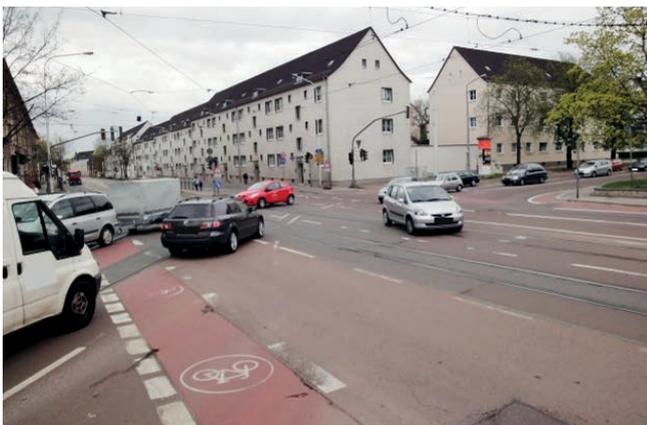
Figure 13: Worn-away/absent guidance and wait lines in junction (accident chart Figure 12)

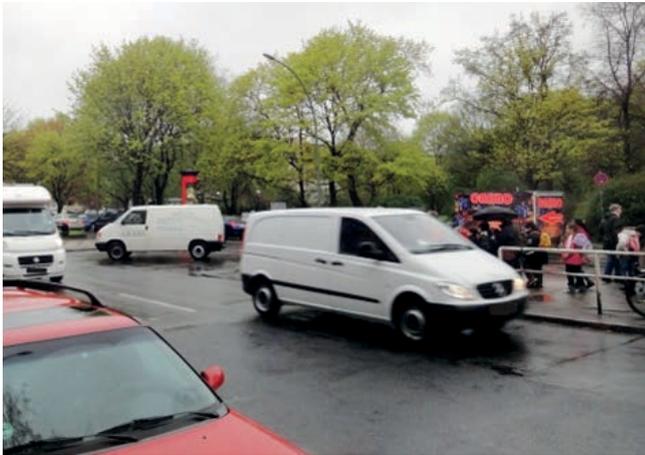
Figure 15:
Absence of road-crossing facilities for pedestrians

- (1) Absence of provisions for pedestrians or provisions not in accordance with applicable guidelines or regulations, in particular road-crossing facilities (Figure 15)
- (2) Cycle path with priority not identifiable at joining road (Figure 16)
- (3) Absence of road-crossing facilities for cyclists (cyclists use road-crossing facilities intended for pedestrians or use cycle paths/sidewalks in the direction opposite to the traffic flow).

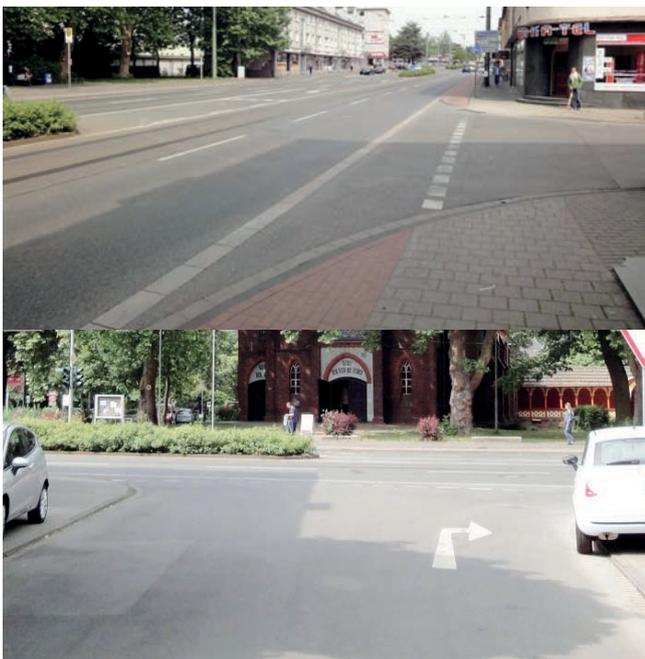
Figure 16:
Unmarked (undetectable for vehicle drivers turning into and off the main road) cycle path priority (different views)
