Compact accident research

Combating accidents on roads outside of built-up areas involving collisions with trees

German Insurance Association

German Insurers Accident Research

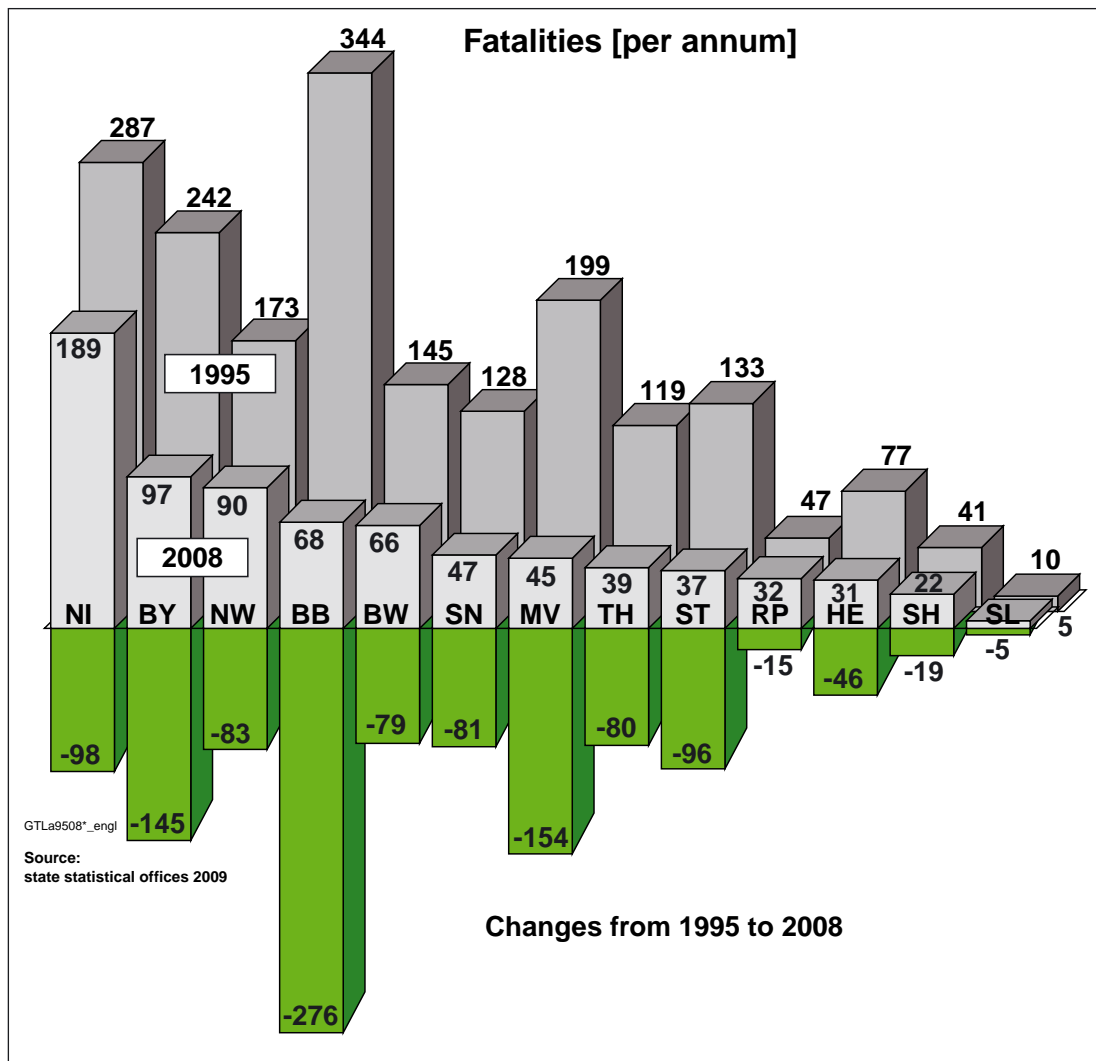
Figure 2: Fatalities as a result of collisions with trees on roads outside of built-up areas by federal state [3]

Figure 2 shows the trend for road fatalities in Germany's 13 non-urban federal states (i. e. not counting Bremen, Hamburg and Berlin) between 1995 and 2008. Brandenburg (BB) had the most fatalities as a result of collisions with trees in 1995 (344). Targeted measures as part of road traffic safety programs reduced fatalities by 80%. 276 fewer people died as a result of a collision with a tree in 2008 than in 1995. In Lower Saxony (NI), on the other hand, fatalities fell by only 34% over the same period, although nationwide fatalities as a result of collisions with trees were reduced by around 60%.

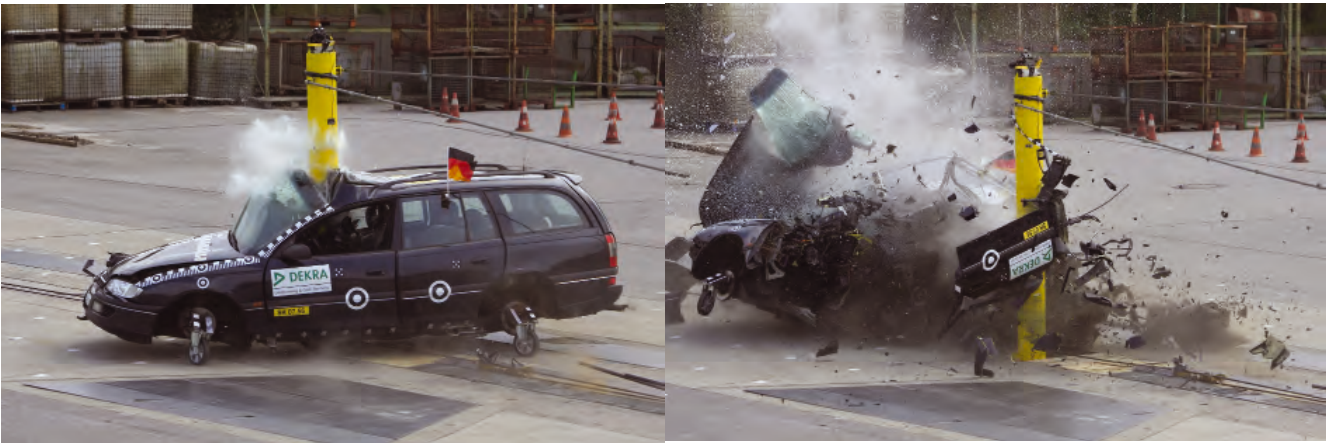
Figure 7: Collision of a 1994 Opel Omega B with a pole at 97 kph at an angle of 23° and with a test weight of 1,656 kg [5]

When a vehicle hits a pole at 97 kph, it is completely torn apart (Figure 7). The vehicle's occupants have no chance of survival, as tests carried out by DEKRA demonstrated [5].

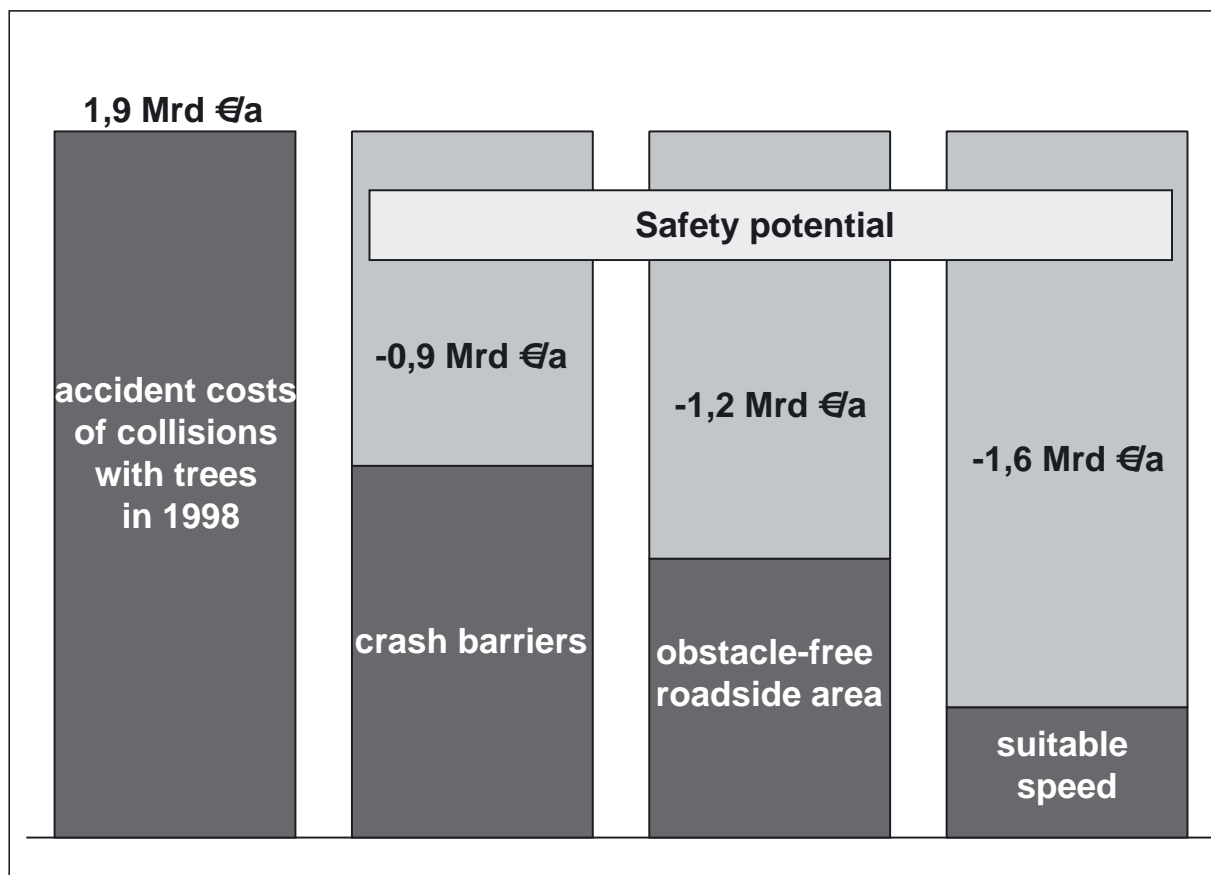
Figure 8: Safety potential (as measured by avoidable accident costs) based on the accidents that occurred in 1998 [9]

cut accident costs resulting from collisions with trees by around half (Figure 8). These measures can generally be quickly and easily implemented at existing black spots, and in some situations it is acceptable to reduce the width of the carriageway in order to widen the road's shoulder. This can also be done on stretches of tree-lined roads with significant numbers of accidents when the full effect of crash barriers cannot be obtained due to the fact that there is not enough space between the crash barrier and the trees in most cases. The important thing here is to prevent direct collisions with trees.

be necessary to remove trees beside existing sections of roads with significant numbers of accidents. This can cut accident costs resulting from collisions with trees by around 60% (Figure 8). The same applies when new roads are built outside of built-up areas. New trees at the roadside become dangerous obstacles in a relatively short space of time (after five years at the latest) – before it becomes evident in the accident statistics.

Reducing the speed limit, adjusting it to suit the road as it stands and enforcing the limit in both directions by means of fixed speed cameras has proved to be one of the most effective measures that can be taken. This can cut accident costs resulting from collisions with trees by up to 80% (Figure 8). The latest results of the large-scale study of safety on roads outside of built-up areas carried out by the Federal Highway Research Institute (BAST) together with road construction authorities in selected federal states and the Technische Universität Dresden confirm that sequences of fixed speed cameras improve road safety overall over the longer term [10].
